Mid Term Visit

5 bedroom furnished
house – 2 rooms
changing over

30/08/2019 –
Mid term change
over

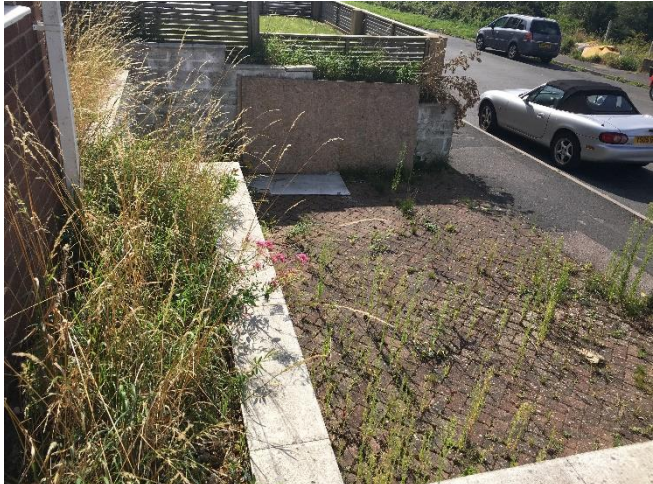
Comments	Photo
<p>Front Exterior Heavily overgrown</p>

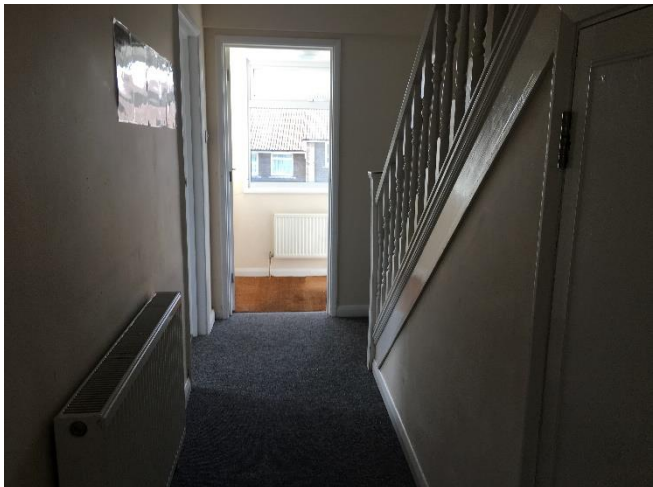
<p>Hallway All lights now not working , 2 x not working on inventory Everything seen as per the inventory</p>

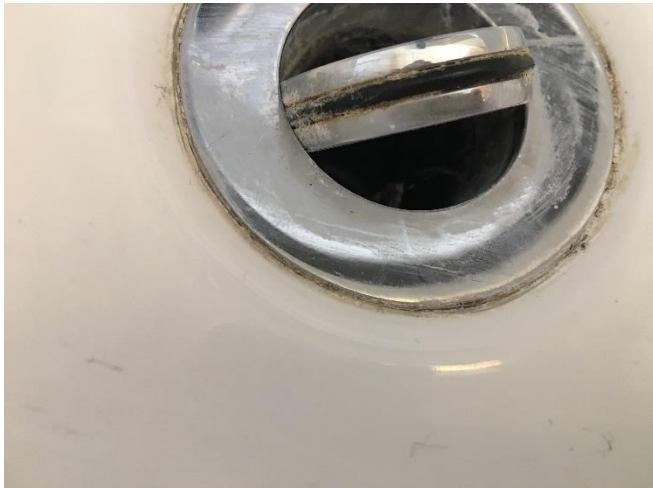
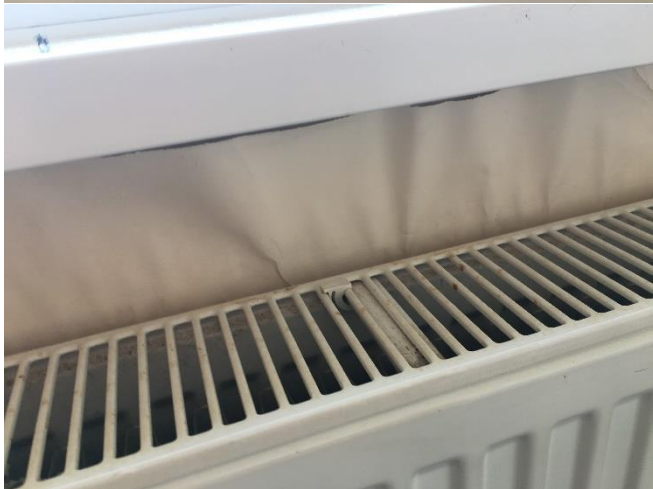
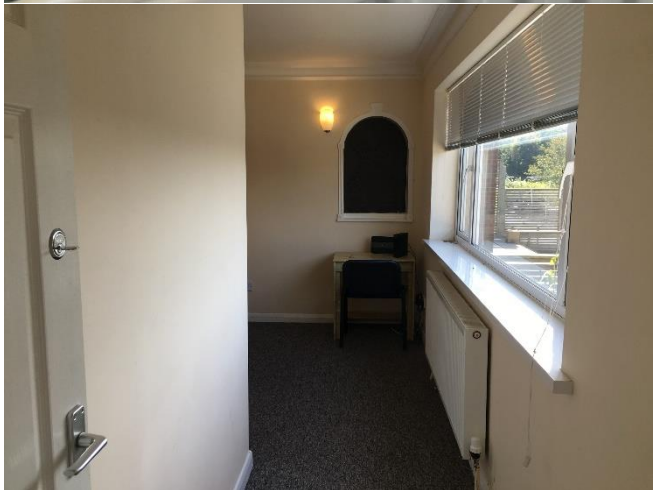
Comments	Photo
<p>Bedroom 1</p> <p>1 x key seen in door , 1 x key on desk</p> <p>Cleaned to a good standard throughout with some lime scale in sink only</p> <p>Walls have some light additional usage , heavy paper peeling noted on inventory</p> <p>Paper lifting heavily from drying clothes behind radiator</p> <p>Everything seen as per the inventory</p>

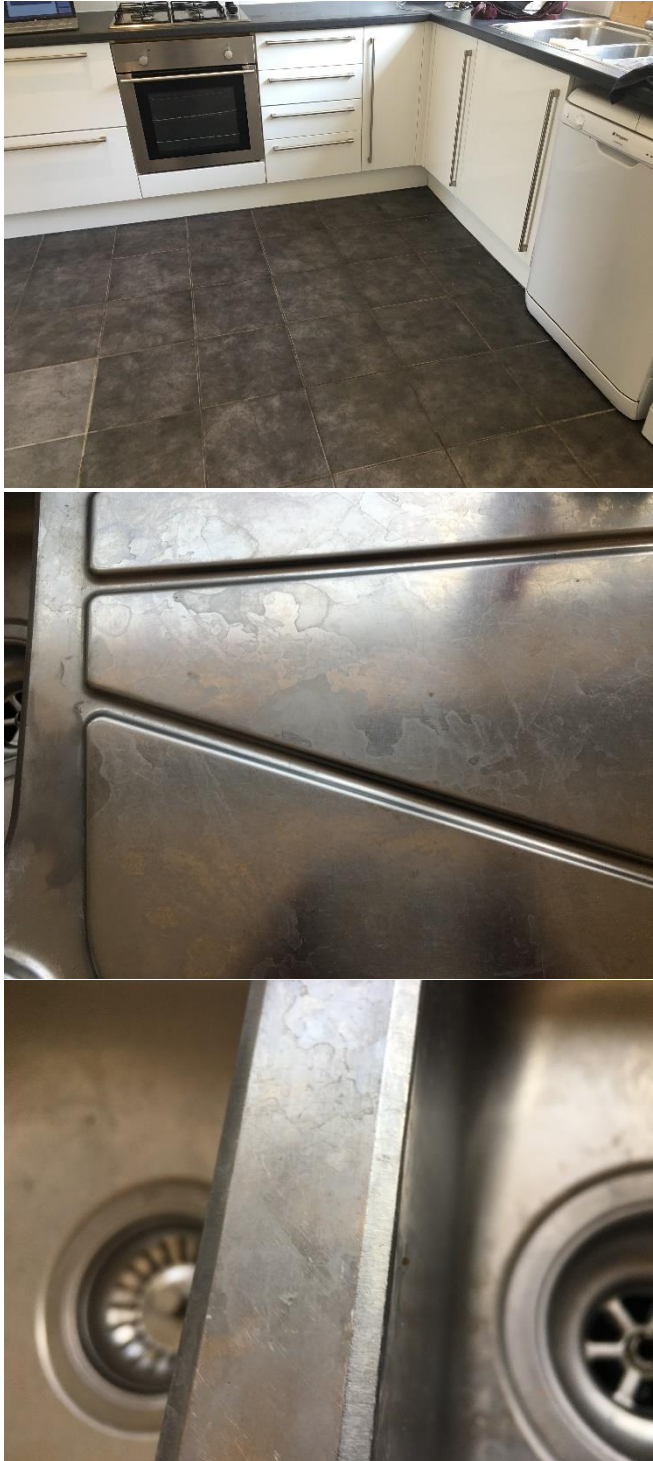
Comments	Photo
<p>Kitchen</p> <p>Domestic cleaned to a good standard , heavy lime scale to sink , units have been cleaned , oven cleaned to a good domestic standard , extractor hood slightly sticky to touch , fridges all cleaned</p> <p>Everything seen as per the inventory</p>

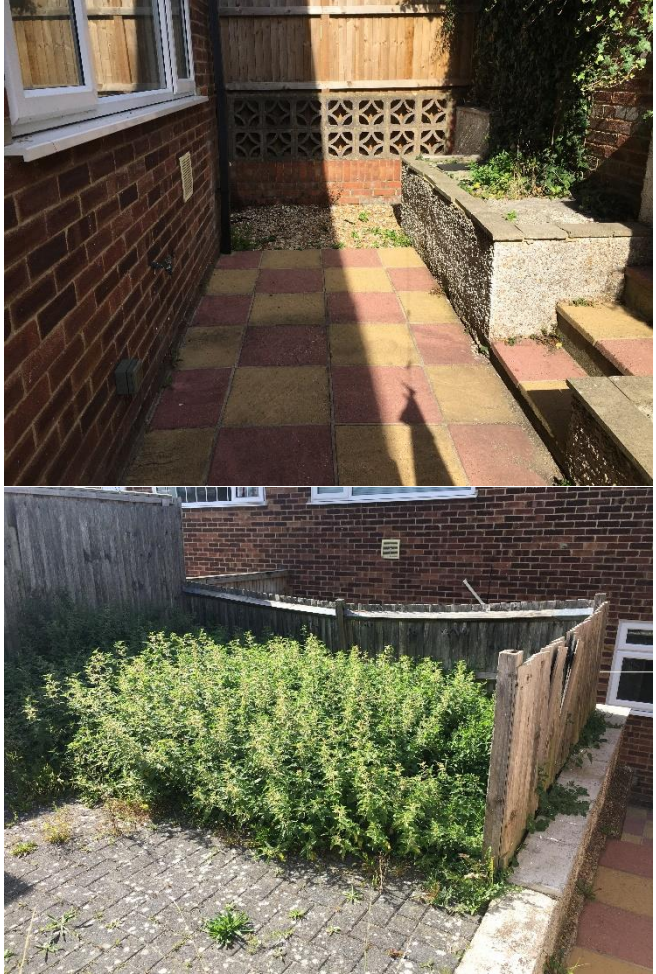
Comments	Photo
<p>Garden Rear Overgrown to back area , patio area tidy</p>

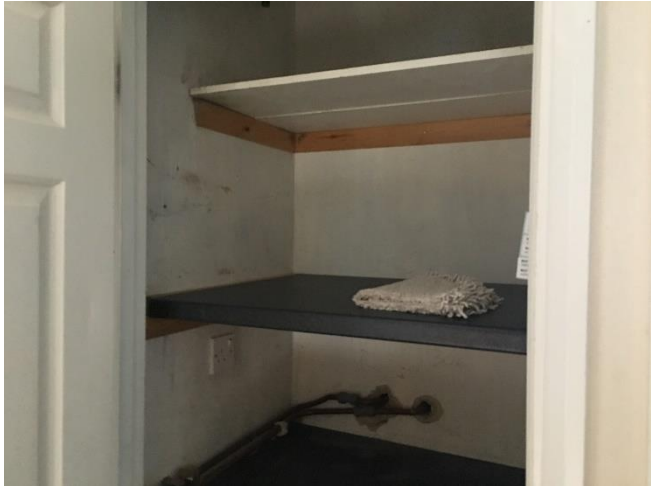
Comments	Photo
<p>Stairs / Landing</p> <p>Contents in cupboard listed on inventory no longer seen</p>

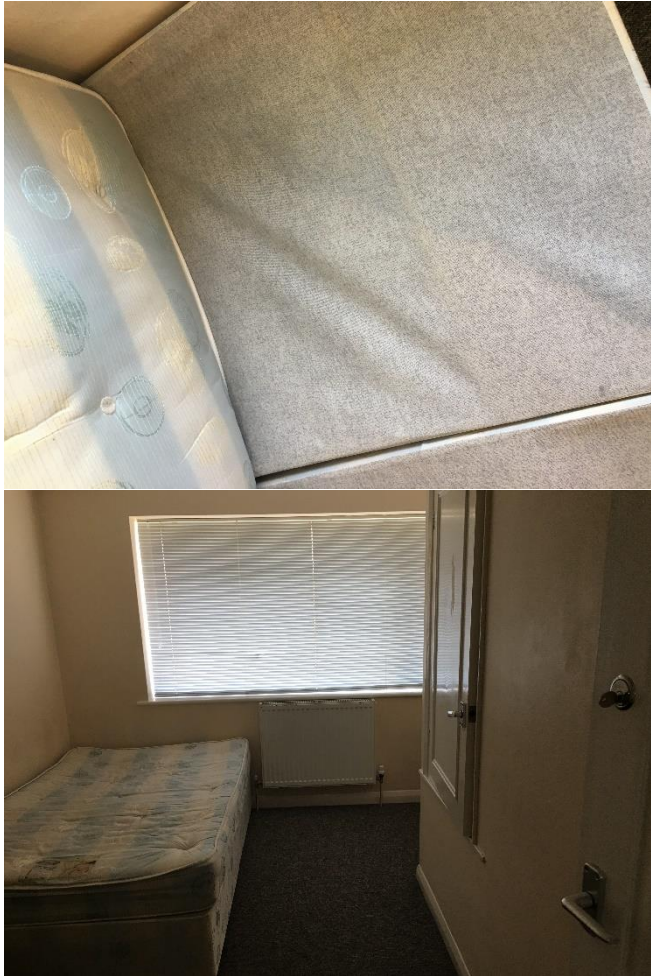
<p>Bedroom 2 – Not inspected as tenant still residing</p>	
<p>Bedroom 3</p> <p>1 x door key and 1 x room key seen</p> <p>Cleaned to a good standard throughout</p> <p>Lighting 1 x not working as per inventory</p> <p>Walls have additional usage and some blue tack marks added over bed</p> <p>Bed heavily dipped to bed base on one side as noted on inventory</p> <p>Desk changed from one noted on inventory</p> <p>Everything else as per the inventory</p>

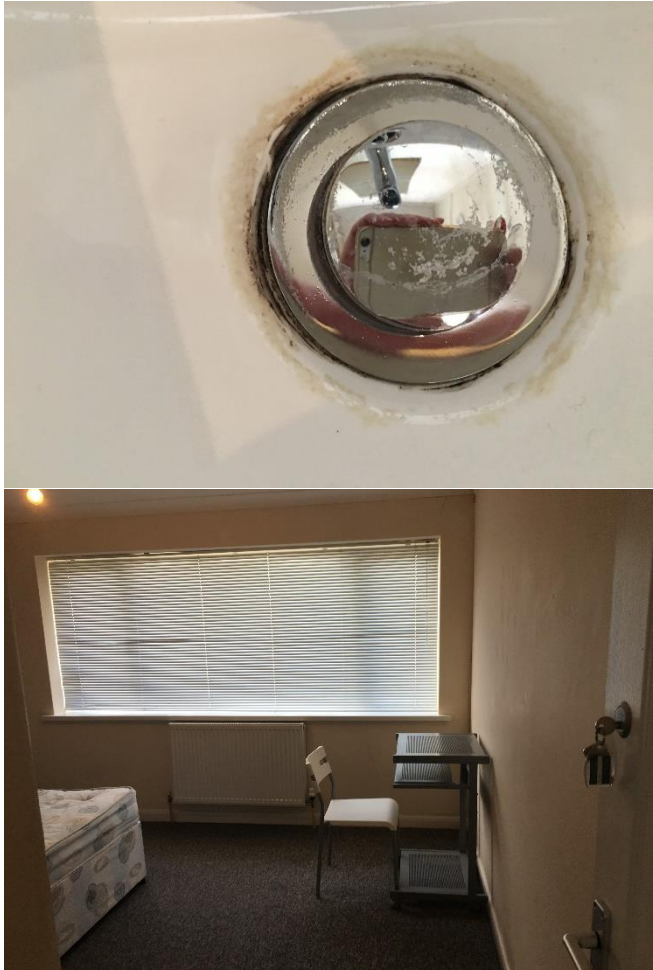
Comments	Photo
<p>Bedroom Four</p> <p>Cleaned to a good standard apart from sink</p> <p>Everything as per the inventory</p>

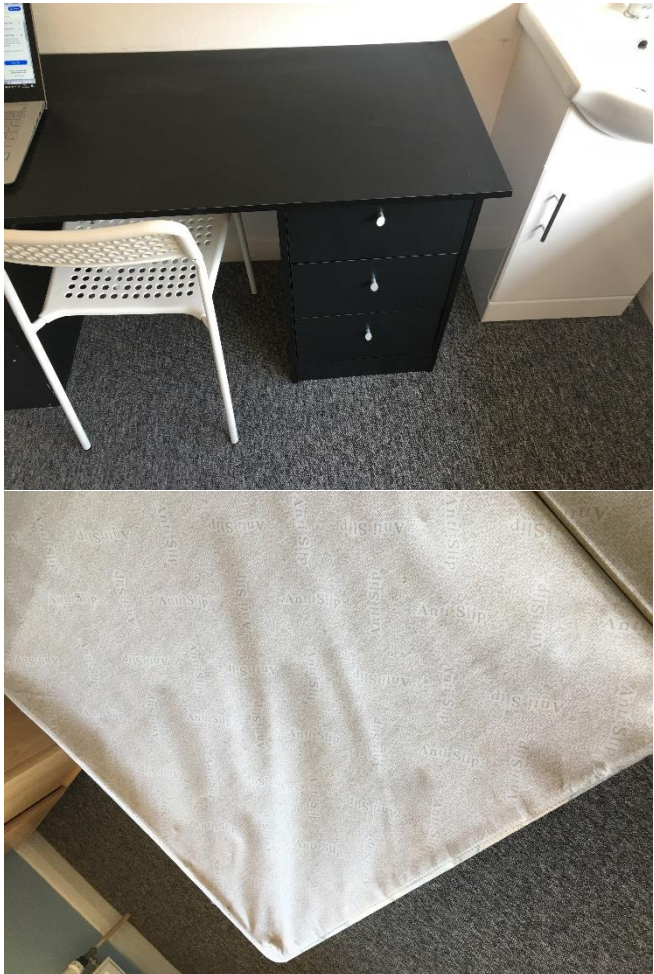
Comments	Photo
<p>Bedroom Five</p> <p>Cleaned to a good standard</p> <p>Bed has dipped , desk changed , additional marks to walls</p> <p>Everything else as per the inventory</p>

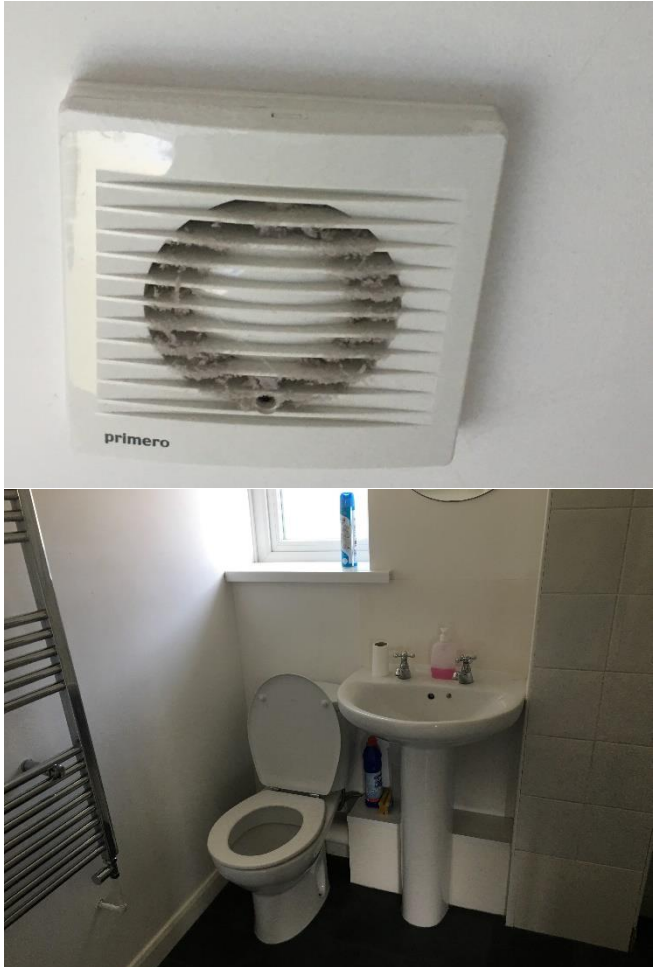
Comments	Photo
<p>Bathroom</p> <p>Cleaned to a good standard apart from fan very dusty</p> <p>Everything else as per the inventory</p>

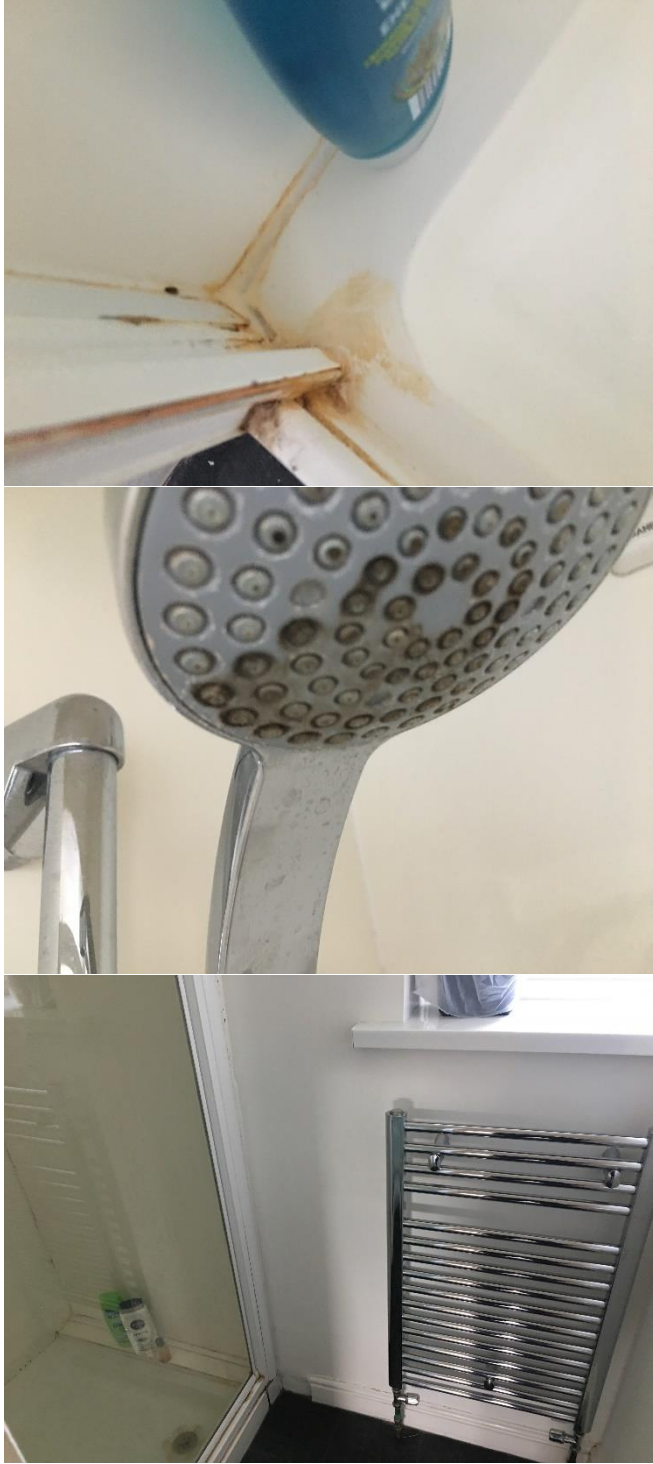
Comments	Photo
<p data-bbox="148 203 319 237">Shower Room</p> <p data-bbox="148 280 790 313">Domestic cleaned with some further cleaning needed</p> <p data-bbox="148 356 579 389">Everything else as per the inventory</p>
