Mid Term Visit

5 bedroom furnished
house – 2 rooms
changing over

30/08/2019 –
Mid term change
over

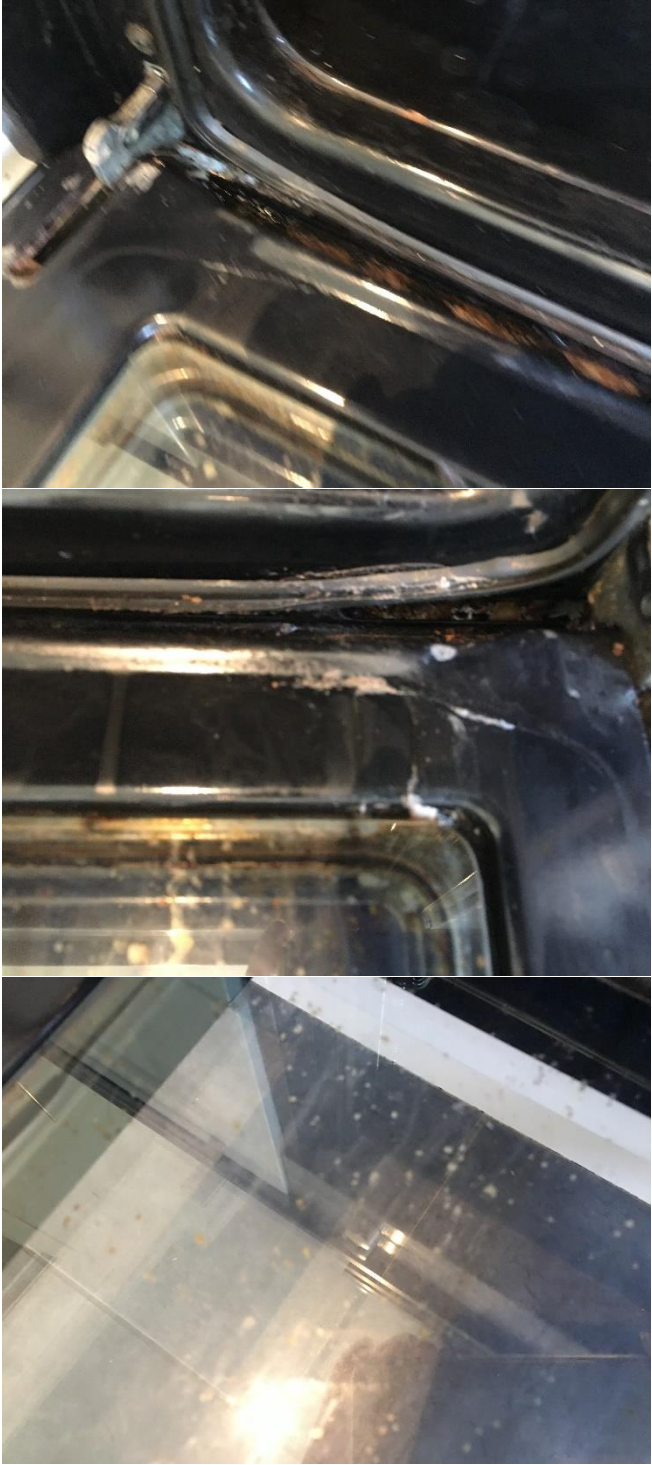
Comments	Photo
<p>Kitchen</p> <p>Domestic cleaned to a good standard , heavy lime scale to sink , units have been cleaned , oven cleaned to a good domestic standard , extractor hood slightly sticky to touch , fridges all cleaned</p> <p>Everything seen as per the inventory</p>

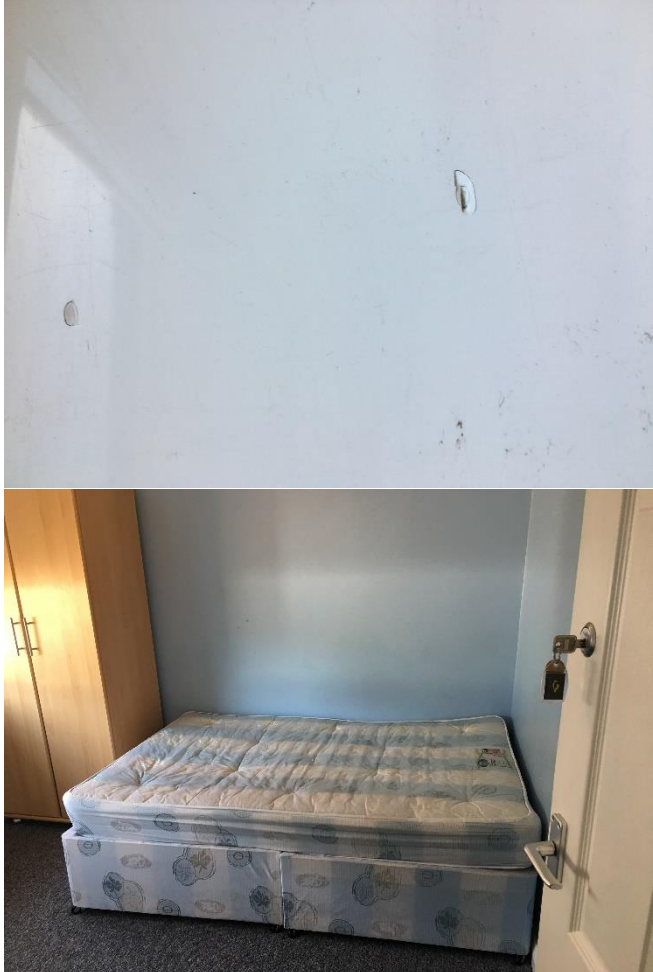
Comments	Photo
<p>Bedroom Five</p> <p>Cleaned to a good standard</p> <p>Bed has dipped , desk changed , additional marks to walls</p> <p>Everything else as per the inventory</p>
